**FIELD SUMMARY REPORT  
INSPECTION OF THE PASCOAG UPPER RESERVOIR DAM  
LOW LEVEL OUTLET**

**Pascoag, RHODE ISLAND**

**OCTOBER 2010**

**REPORT PREPARED BY  
INNER TECH MARINE SERVICES LLC**

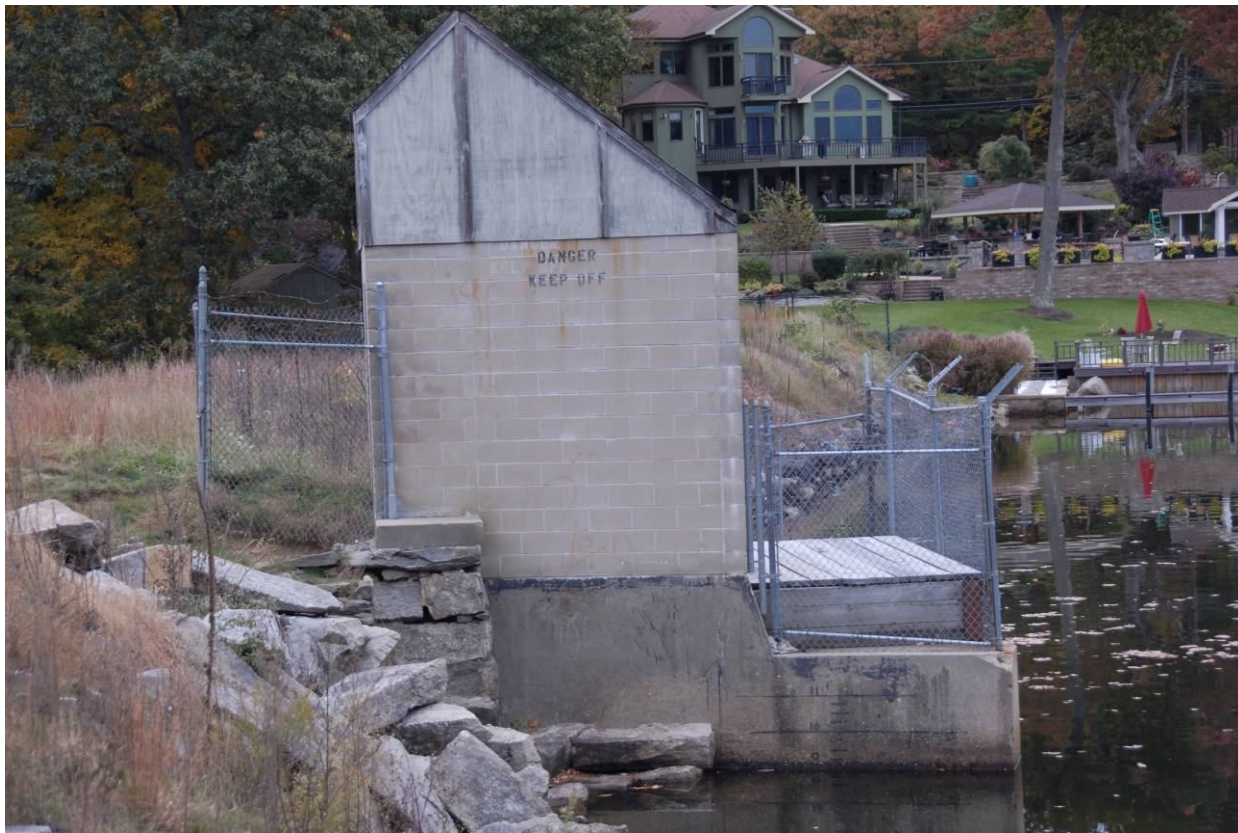
**Photograph No. 1, gate house**

**Description:** The gate house consists of a concrete walled structure with opening to the dam upstream. The gate house has a bar trash rack over the discharge opening and a control gate with hoister and stem rod connection to the gate. It is believed that the concrete gate house is a newer structure, built

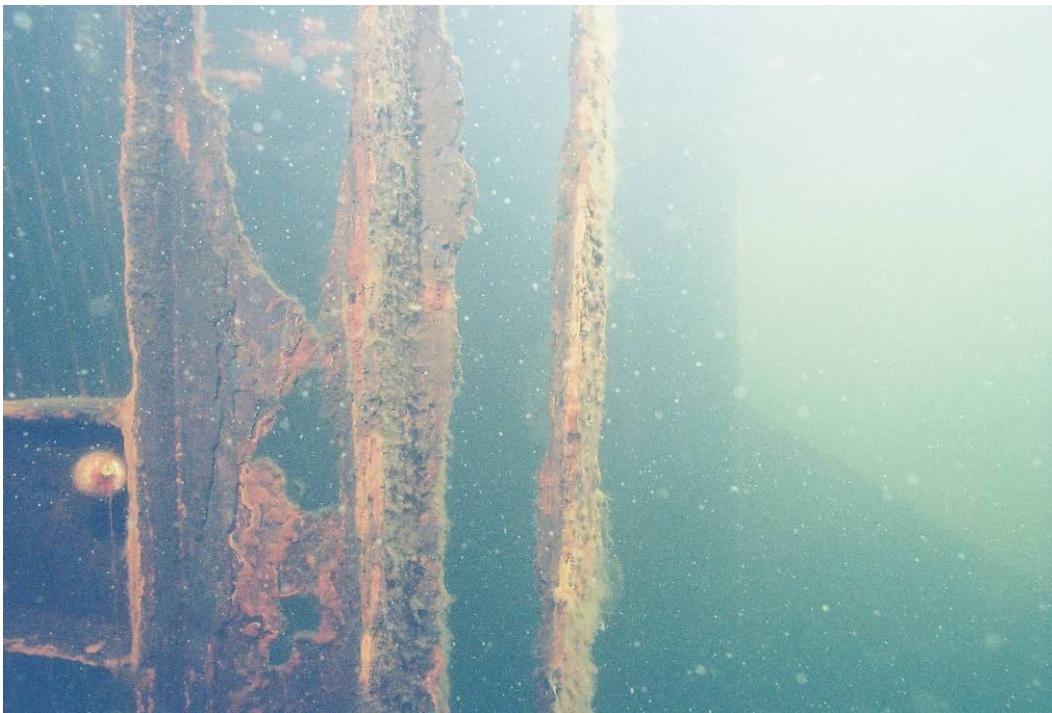
Directly in front of the trash rack and in the center of the opening are two vertical "I" beams connected flange to flange. The I beams provide support for the platform above and center support for dewatering timbers which can be placed in stop log channels cast in either side of the concrete opening (See photograph #7 following). The I beams are braced horizontally by steel support members which are connected to horizontal trash rack supports behind (Note figure 1 following). The vertical I beam and horizontal supports are heavily rusted and deteriorated (75 -90%) and their web sections are perforated and very weak (See photograph No. 3, 4, following). The trash rack is supported by two horizontal I beams which span the gate house opening. The beams are spaced approximately 4 feet apart off the floor and above. The lower beam section measures approximately 12X16 inches and is approximately ½ inch in thickness. The beam appears heavily rusted and has sectional loss from deterioration of approximately 15-25%. The upper beam measures approximately 8 X 12 inches and is approximately 3/8 to ½ inch in thickness. The beam appears heavily rusted, the edges of the flanges are somewhat "knife edged" and the beam has sectional loss from deterioration of approximately 25-50%. The beams are connected to the gate house walls via flange brackets which are anchored into the walls using approximately ½ inch fasteners. The fasteners were heavily rusted.

**PHOTO #3, SHOWING VERTICAL I BEAMS WITH PERFORATED WEB SECTION**

1. Support vertical I beams and horizontal braces under the platform are very deteriorated with perforation of web sections.
2. The trash rack has deterioration to underwater sections but may be serviceable.

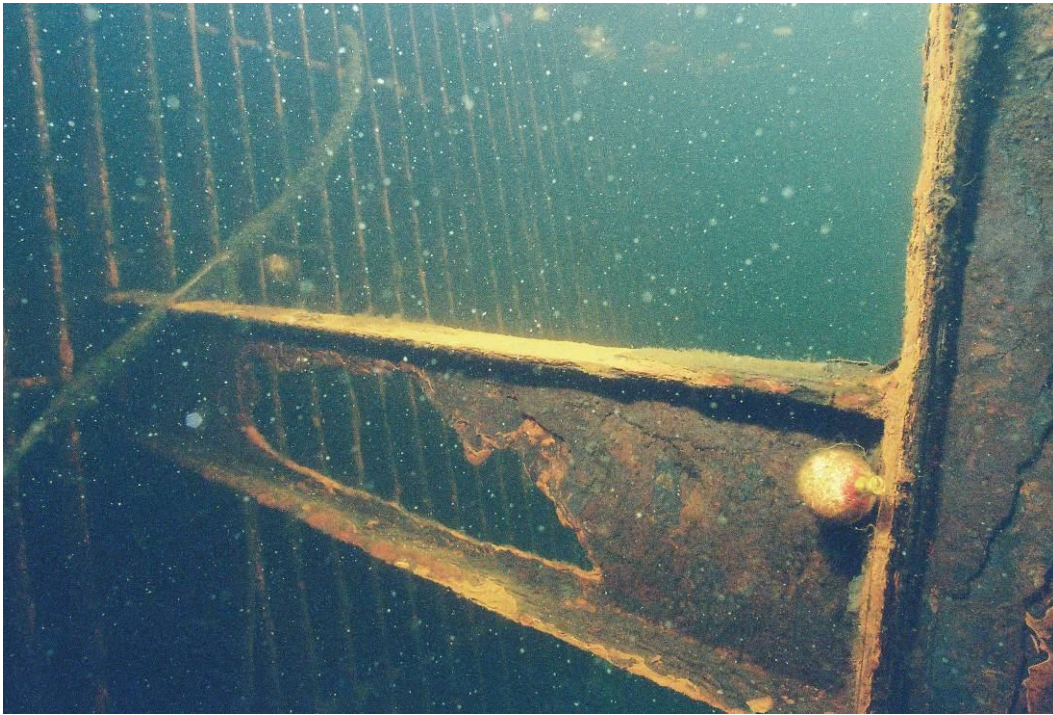
**PHOTO #4 SHOWING HORIZONTAL BRACE WITH PERFORATED WEB SECTION**

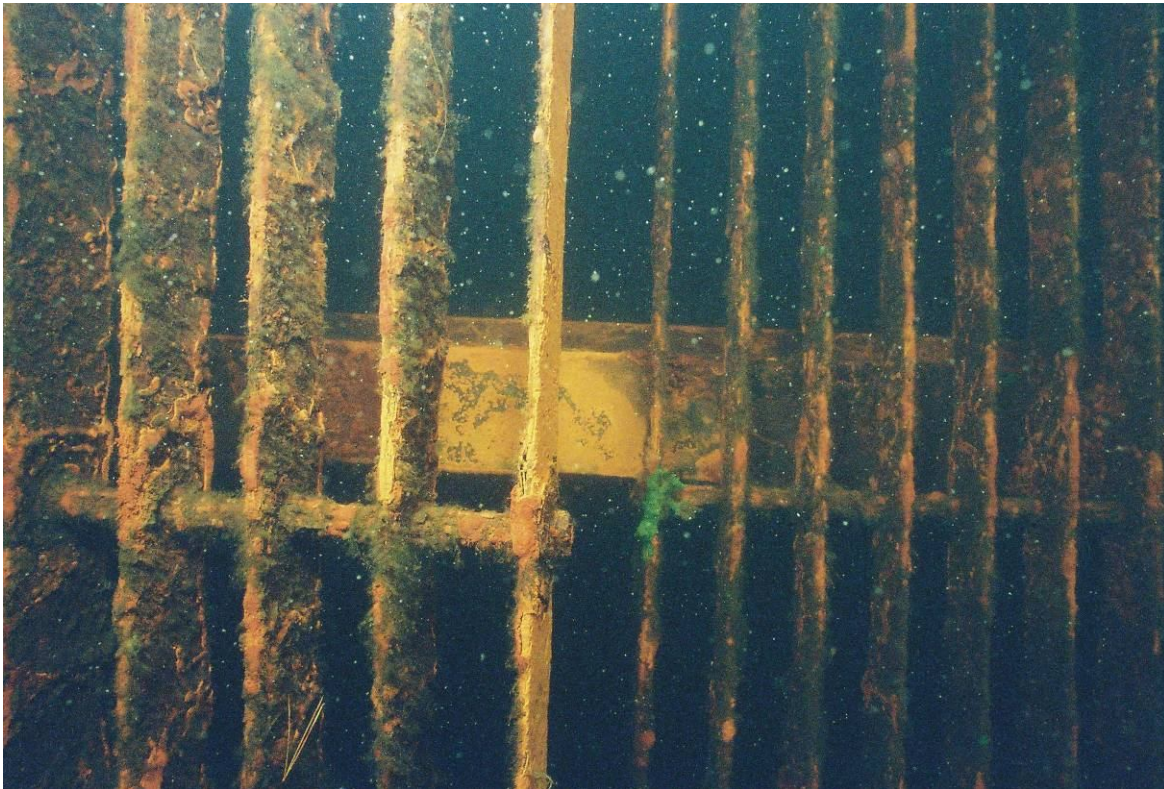
**1. Trash racks and supports:** The trash rack consists of multiple, approx. 4 foot sections spanning the gate house opening. The trash rack is constructed of approx. 4 inch X ¼ inch steel bars spaced approximately 4 inches apart. Sections of the trash rack above the water appear original in thickness and are in good condition, sections of the trash rack below water, particularly just below the average water line show heavy rust and deterioration reducing the bar thickness by 25 to 50% (See photograph No. 2, following). Fasteners holding the bars together appeared heavily rusted. A section of rack was pulled forward to gain access to the gate. The section appeared reasonably sound and did not fall apart during the move.

**PHOTO #2 SHOWING TRASHRACK DETERIORATION, NOTE HORIZONTAL SUPPORT BEHIND**

3. The horizontal support I beams behind the trash rack have some deterioration but may be serviceable.
4. The bracket connection from the support I beams to the wall has deterioration to the fasteners.

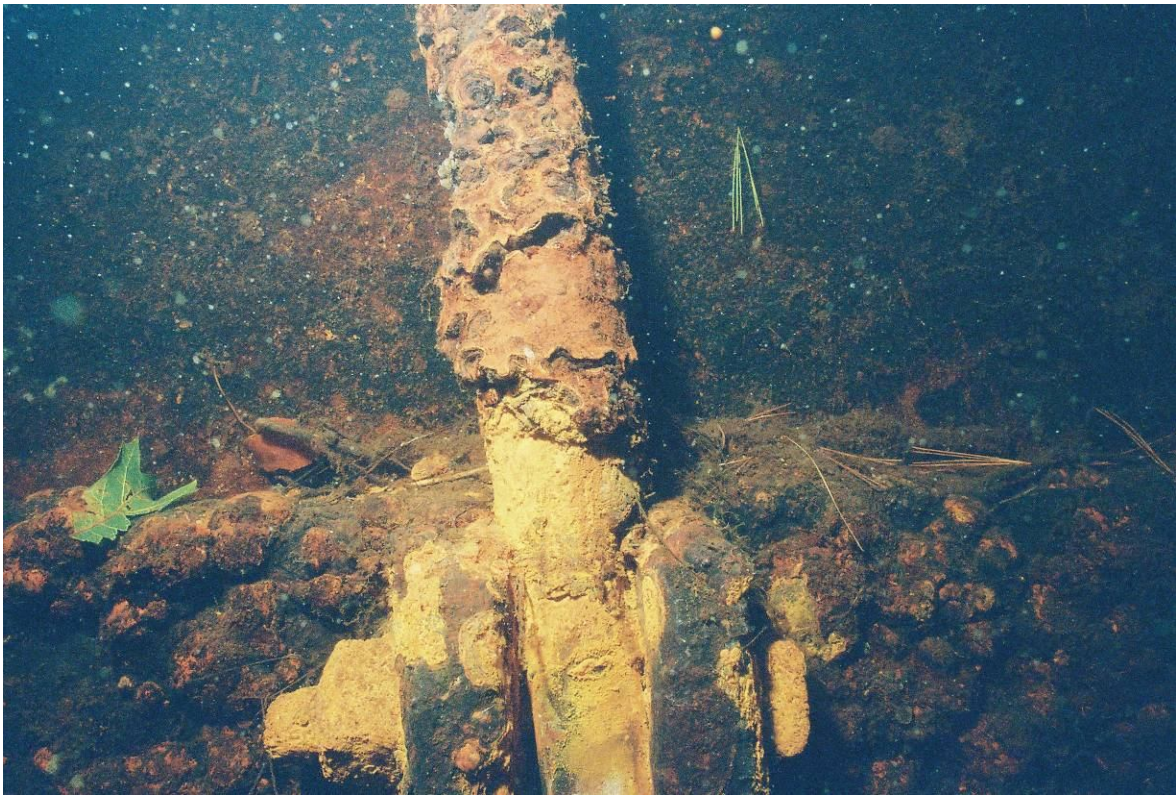
The gate is opened and closed via a steel shaft measuring approximately 2 ½ inch in diameter. The steel shaft or “stem” is heavily rusted. The stem is severely bent in an “S” shape, most likely from over closing or excessive down force needed to close the gate. The lower section of stem terminates in an approximately 4 inch square stainless steel member spliced (welded) onto the round stem section. The stainless member sits in a rectangular pocket cast into the gate. The stainless member is through bolted (approximately 1” bolt) through the cast in pocket in the gate. Smaller fasteners were also noted in the face of the stainless member. These fasteners are believed to be threaded through the stainless into threads cut into the face of the gate pocket. The fasteners were rusted and loose, some evidence of the square stainless member twisting in the square cast gate pocket was evident. Figure 2 and photographs No’s 5 and 6, following, show additional details of gate construction and condition. No upper stem guides, to control flex in the stem, were observed. The stem is flange coupled above and out of the water to an acme threaded stem (approximately 3 inches in diameter) section passing through a hole in the gate chamber floor.

**PHOTO #5 SHOWING CONNECTION OF STEM TO GATE, NOTE THROUGH FASTENER**

8. The existing stem appears to be twisting in the pocket which connects the stem to the gate.

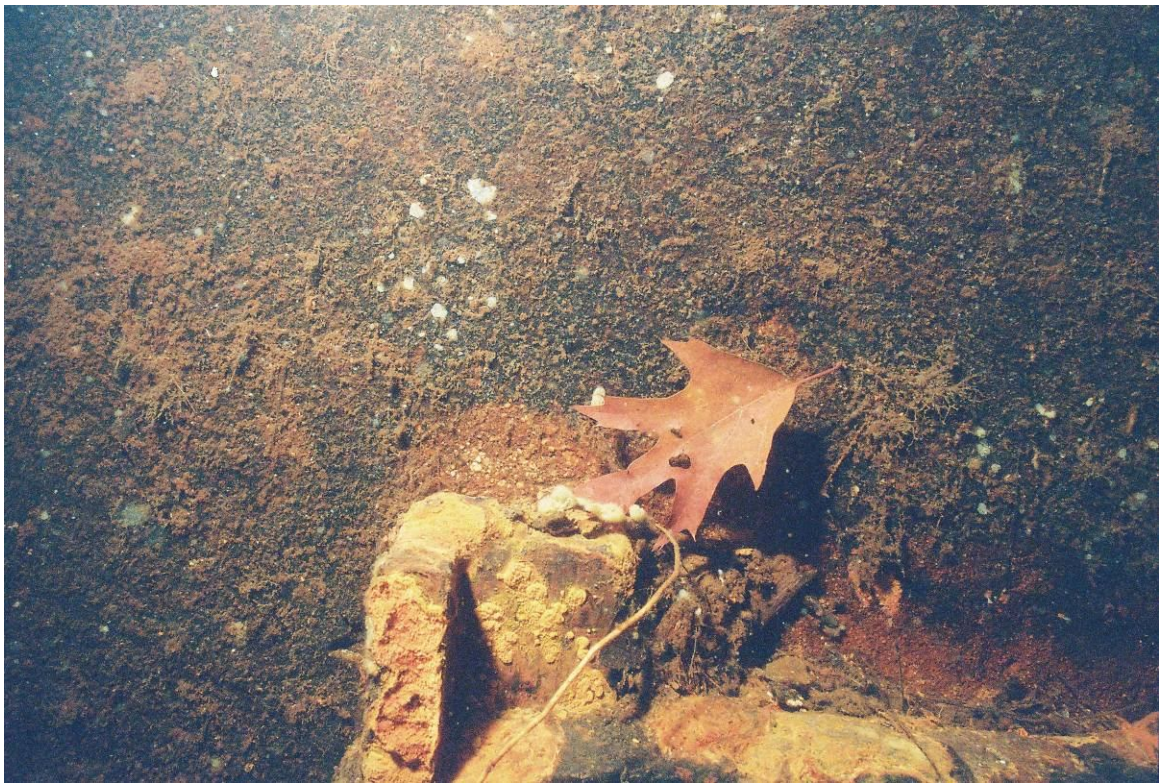
this softness was due to chipping on outer layers of deterioration or deeper deficiencies in the cast iron. There are no upper gate guides above the gate frame to guide the gate back over the opening. The gate appeared opened approximately 1-2 inches, enough to cause a leak across the bottom but apparently not opened above the square gate frame behind. Some leakage was noted along the sides of the gate. Sticks and debris were mostly clogging the openings and controlling leakage.

**PHOTO #6 SHOWING TOP OF GATE GUIDE, CAMERA FACING FLOOR**

6. The gate frame does not have upper guides causing the gate to skew in the guides below during closing.
7. The gate cast iron appeared to be somewhat soft when probed with a pick; the gate is leaking which suggests deterioration to sealing surfaces.

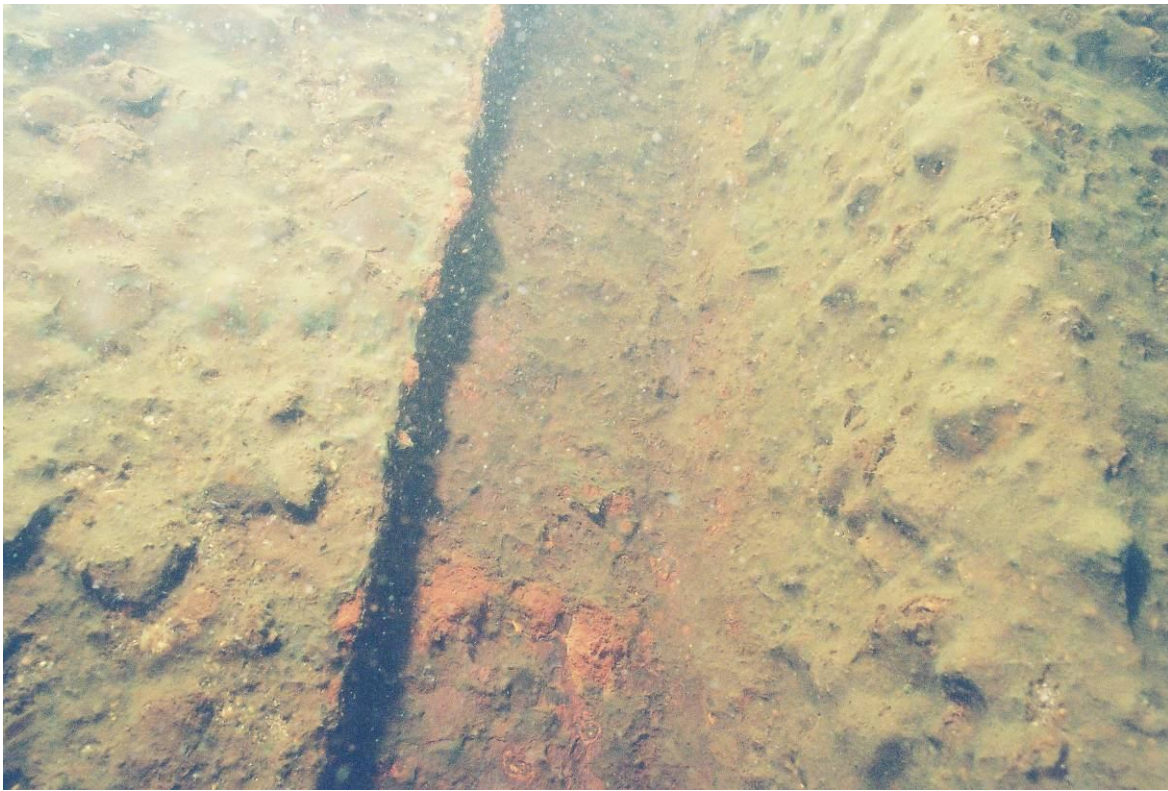
**PHOTO #7 SHOWING STOPLOG CHANNEL CAST IN GATE HOUSE CONCRETE**
