-- PASCOAG RESERVOIR UPPER DAM #16-- VISUAL INSPECTION / EVALUATION REPORT

Dam Name: *Pascoag Reservoir Upper Dam*

Consultant: *Pare Corporation*

Date of Inspection: *May 14, 2010*

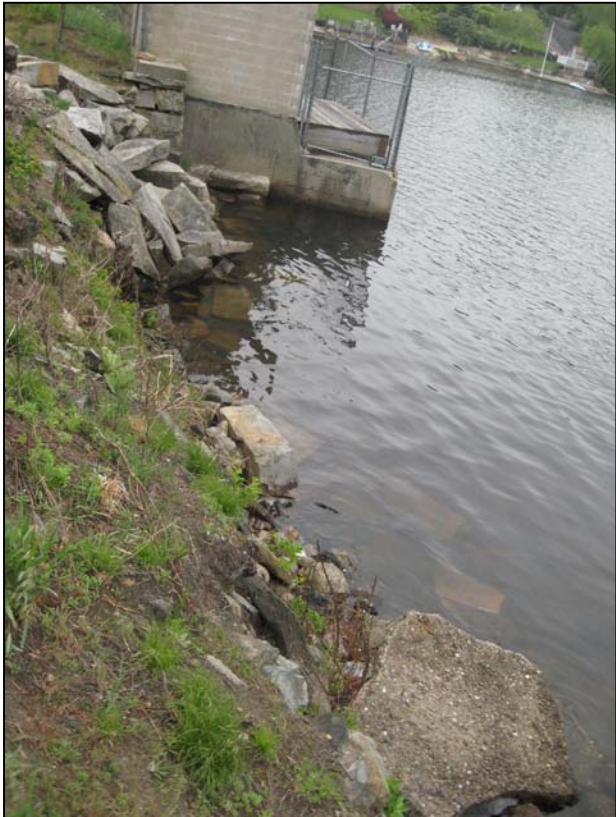
- Eroded areas, most likely due to surface runoff, were observed along the upper slope approximately 30 feet right of the low level outlet and about 20 feet left of the primary spillway.

Photo No. 3: Erosion of the upstream slope left of the low level outlet.

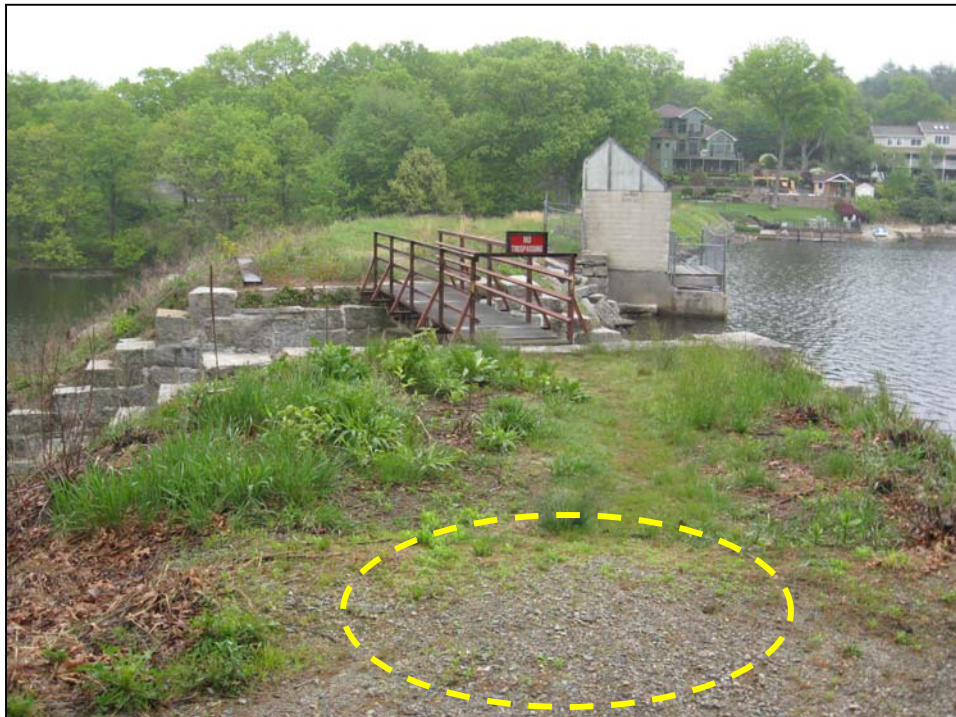
Photo No. 6: Overview of crest in area of the primary spillway looking right. Note eroded area possibly due to foot traffic.

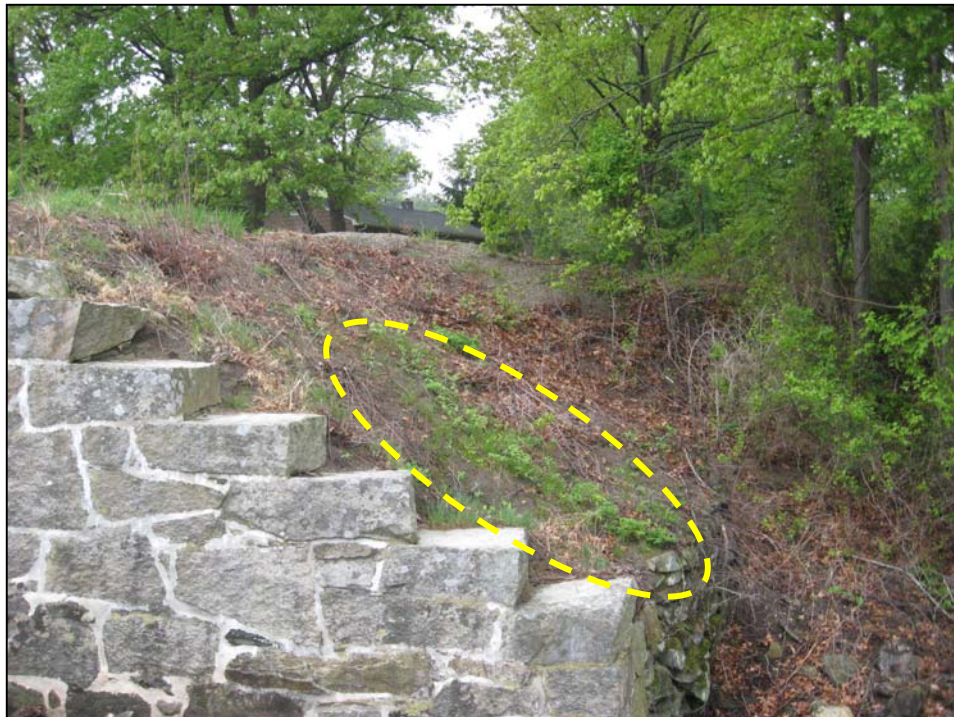
- A large hole about 8 feet long, 3 feet wide and 3 to 4 feet deep was observed left of the primary spillway near the base of the slope. The caretaker said this was reported as a former animal burrow in previous inspections.

Photo No. 12: Overview of the left downstream training wall to the primary spillway. Note location of large hole (8' L x 3' W x 4' D) observed behind wall.

6. Perform a structural evaluation of the left training wall to the primary spillway involving the cause of the formation of the large hole behind the downstream side of this wall. As a minimum, the hole should be backfilled with a compacted structural fill with any necessary mitigation measures to help prevent this hole from forming, based on the findings of the evaluation.

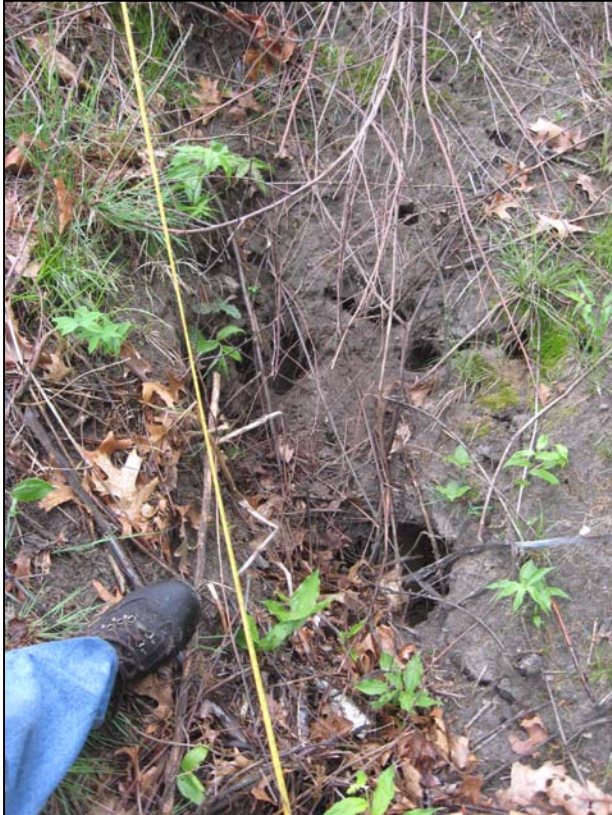
Photo No. 13: Closer view of the large hole observed behind the left downstream training wall to the primary spillway. Note a root mat obstructs the true size of this hole.

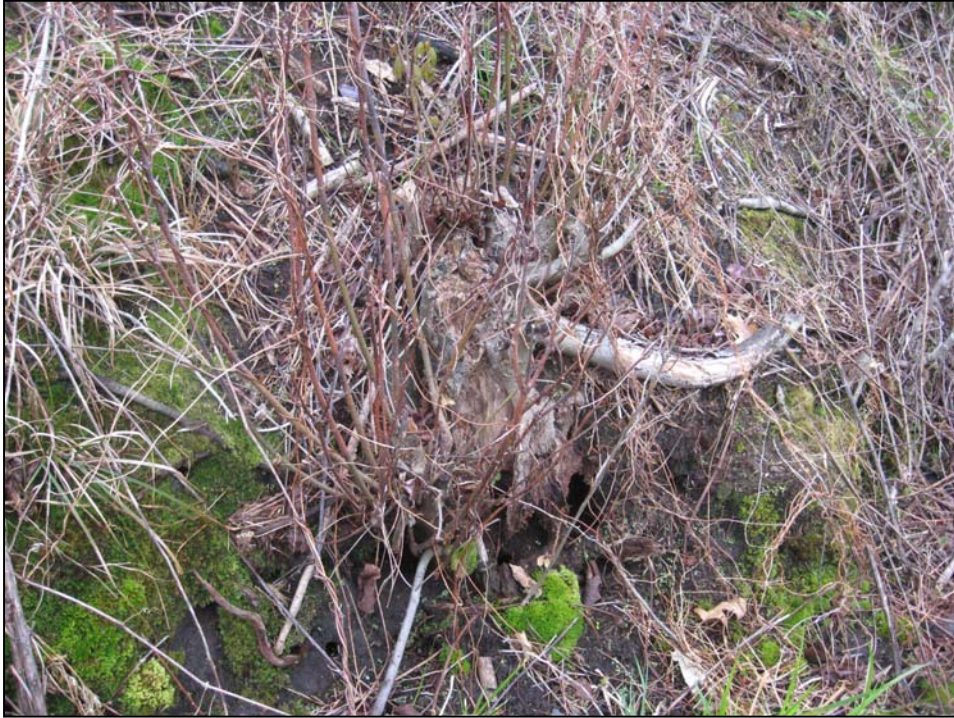
- The vegetation consists of several stumps of various ages of decay, grass and weed growth, and various bare areas. Some stumps were almost completely rotted with holes forming within the embankment along the toe of the dam.

Photo No. 17: Typical rotted stump along based of downstream slope (Photo taken near Station 2+50).

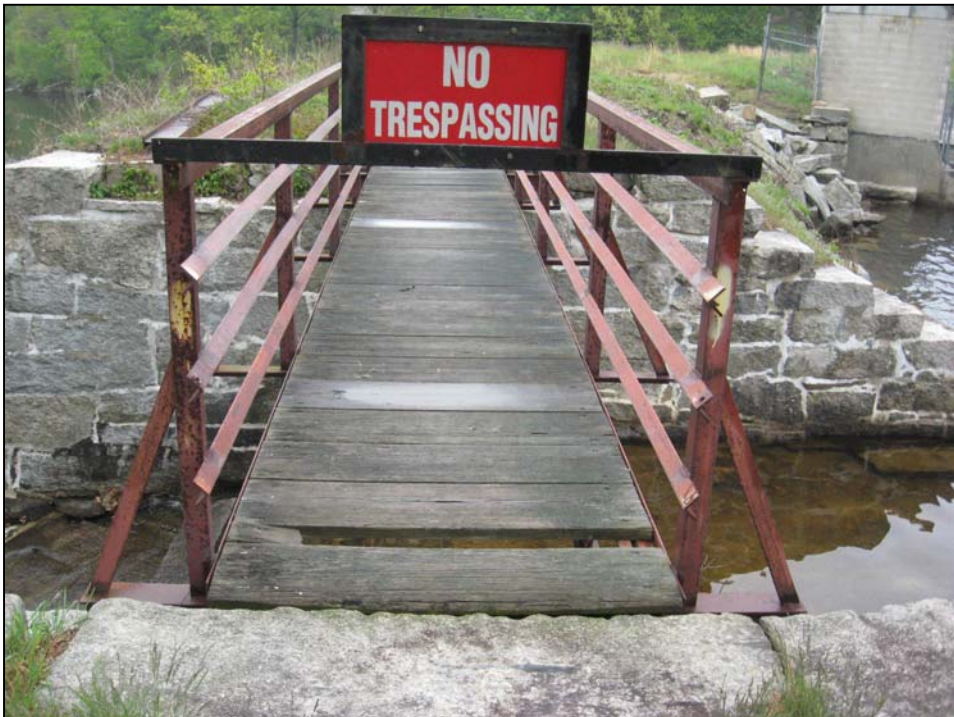
Photo No. 18: Footbridge over the primary spillway looking right. Note broken board.

10. Repair the deteriorated deck to the footbridge over the primary spillway.
11. Repair the downstream headwall and training walls of the low level outlet, including resetting stones, chinking wall joints, and repointing.
12. Clear the vegetation from the island developing within the downstream channel to increase the current outflow capacity of the primary spillway.

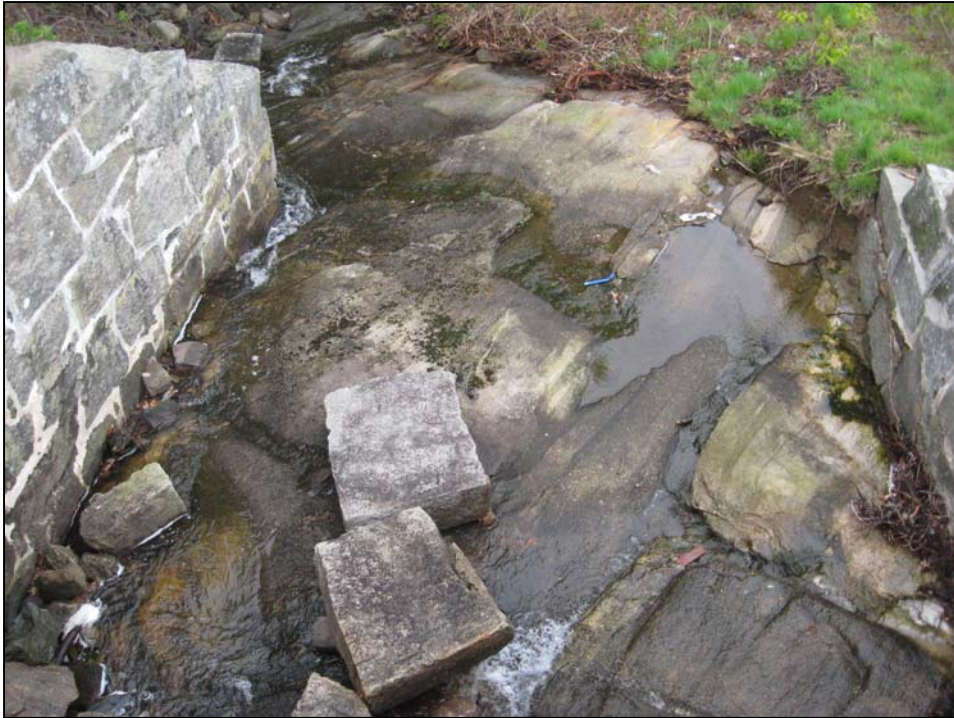
Photo No. 19: Downstream channel to primary spillway. The granite blocks in the channel were removed from the spillway crest as part of previous work.

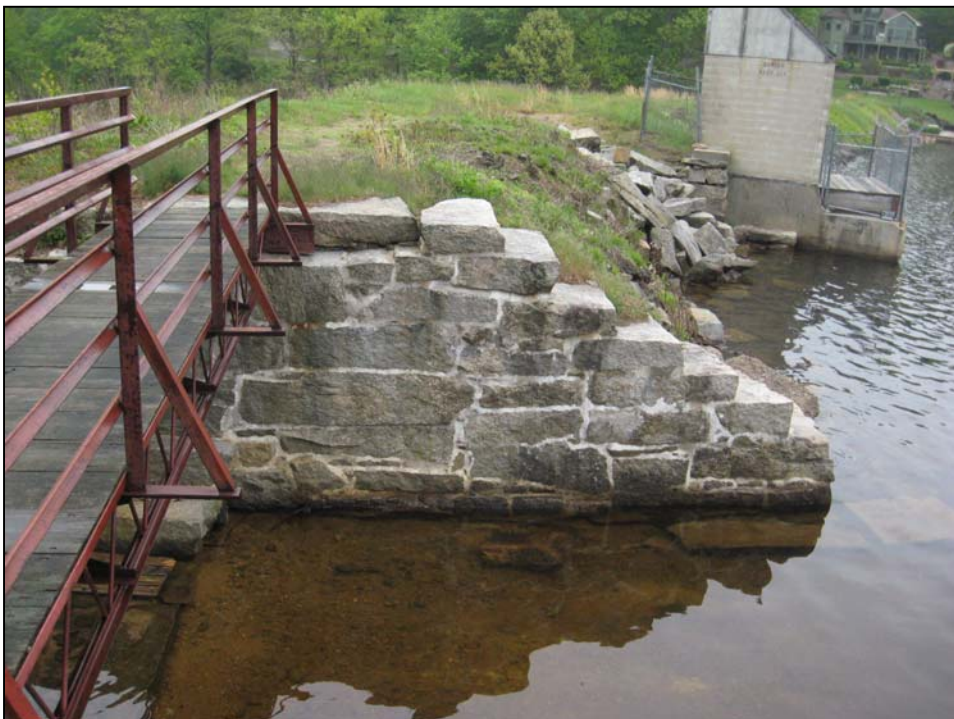
- As observed, the caretaker reported that the granite block training walls have been re-pointed since the previous inspection in 2001. The re-pointing appears okay with no cracks or missing mortar.
- Approximately 0.5-inches of water was flowing over the crest.
- The training walls' vertical and horizontal alignment appears okay.
- The approach and discharge areas were clear.
- The caretaker informed the inspector that the crest of the spillway was lowered by one block height during previous work. The removed blocks remain in the downstream area of the channel.
- The timber deck of the footbridge had one broken board and several aged boards in place but was still able to support foot traffic.
- No leakage was observed.

Photo No. 20: Overview of the right upstream training wall to the primary spillway. Note newly mortared joints.

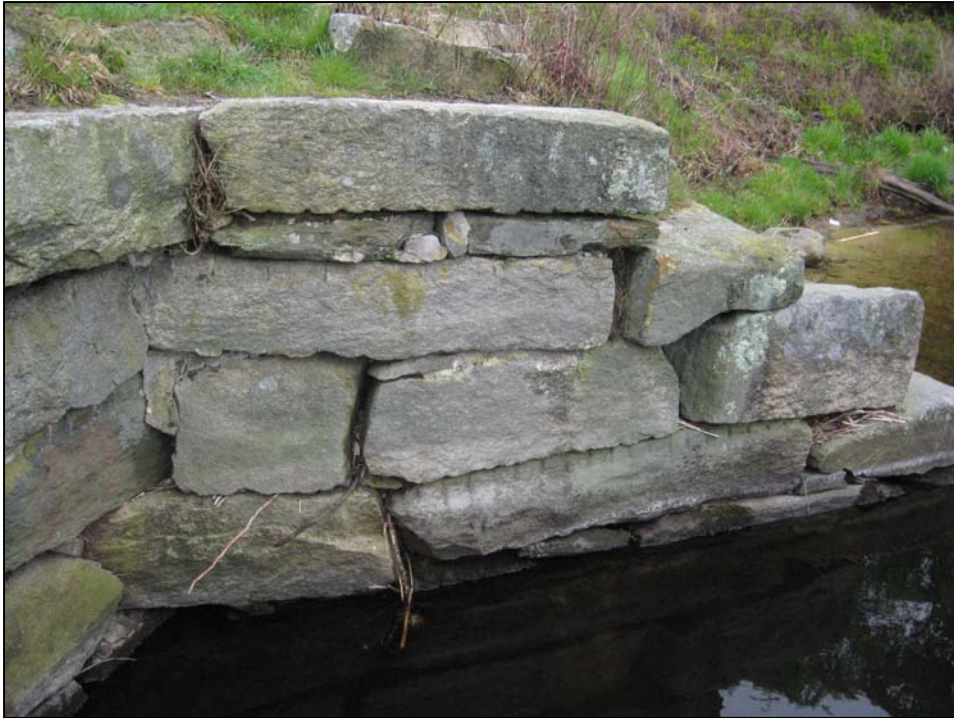
- The approach and discharge areas were underwater and could not be viewed.
- The caretaker stated that the gate was opened 2-inches.
- The caretaker opened the gate another inch to demonstrate its operability. The opening mechanism appeared to operate smoothly.
- The low level outlet concrete structure appeared in satisfactory condition with no major cracking, settlement, or movement observed.
- The downstream headwall was observed with missing chinking stones, missing mortar and tree stumps protruding out some joints with shifted stones.
- No leakage was observed.

Photo No. 23: Left downstream training wall to low level outlet. Note gaps and movement in wall.

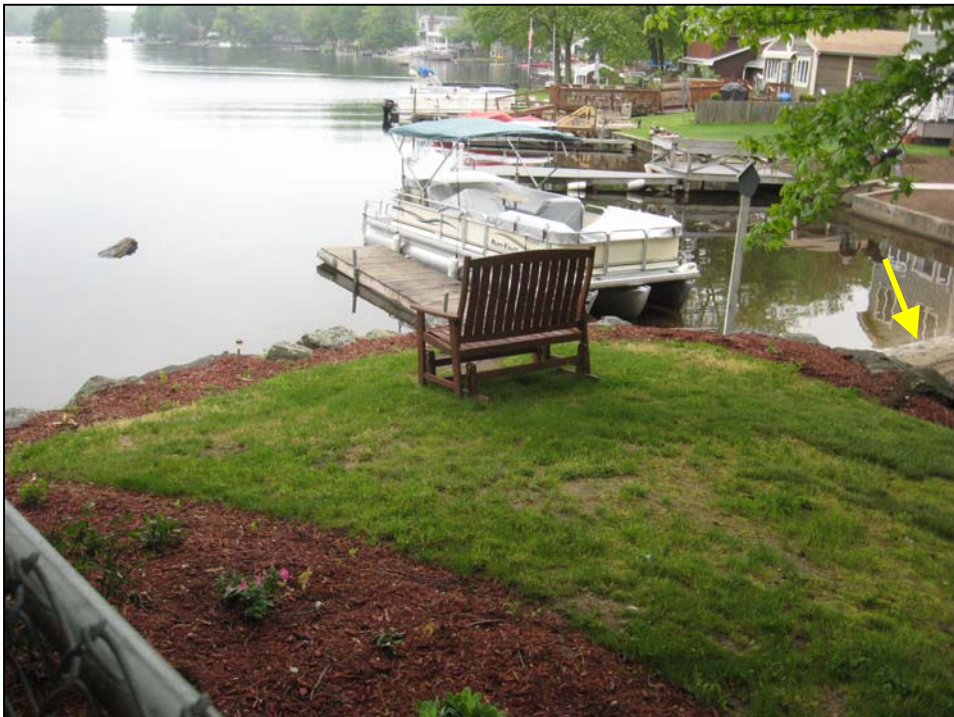
Photo No. 28: Overview of left abutment along the upstream slope of the west dike. Note lower area.

2. Properly fill and regrade the dam crest to a level section with compacted engineered fill.
3. Complete stability analyses to evaluate the current condition of and the movement occurring at the upstream and downstream walls, including the failed section of downstream wall near the left abutment. In order to complete these analyses, completion of a subsurface investigation consisting of soil borings will likely be required to assess the current conditions of the embankment soils and pressures applied to the stone masonry walls. Based on the results of the analyses, rehabilitate the walls in order to provide a stable section. This could include partially or fully rebuilding the walls or installing a buttress against the backside of the existing wall sections.

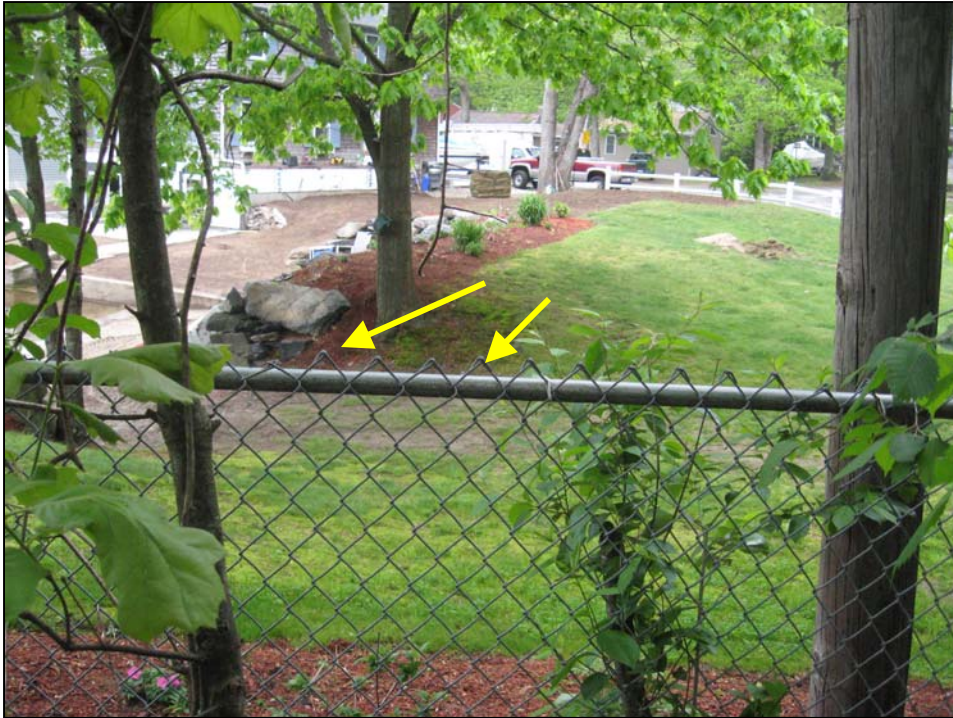
Photo No. 31: Overview of left abutment along the crest of the west dike. Note lower area.

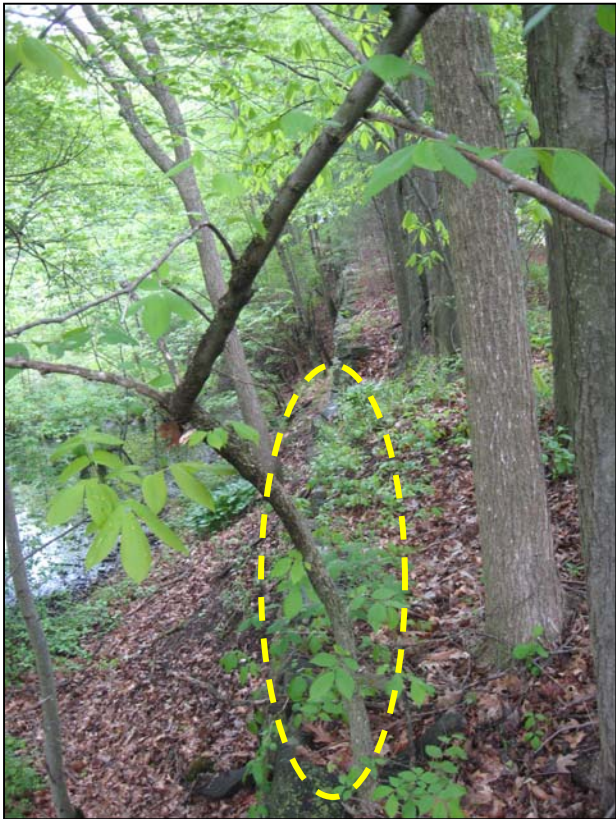
- The downstream walls have a poor vertical and horizontal alignment with bulging observed, apparent sunken tops of walls, and an irregular vertical alignment.
- Some stones were missing within the joints.
- Small to medium trees were observed growing along the toe of the wall.
- A failed section of wall was observed about 30 feet right of the left abutment. Soil has sloughed at this location at about a 1.5H:1V slope.
- Wet areas were observed along the wall.
- Abutment contacts looked good with no unusual movement observed.

Photo No. 35: Section of failed downstream wall of the west dike as viewed from Station 0+40 looking right.
