**FIELD SUMMARY REPORT
INSPECTION OF THE PASCOAG UPPER RESERVOIR DAM
LOW LEVEL OUTLET**

Pascoag, RHODE ISLAND

OCTOBER 2010

**REPORT PREPARED BY
INNER TECH MARINE SERVICES LLC**

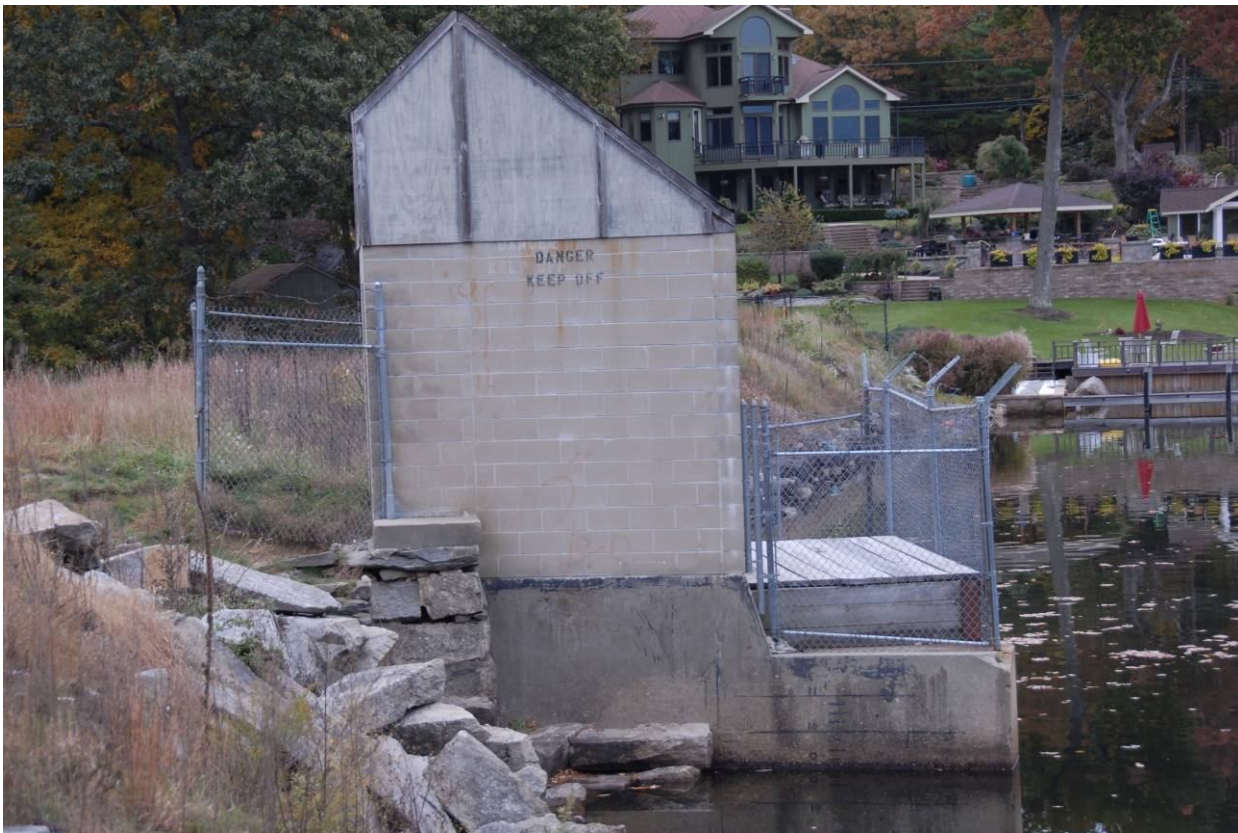
Photograph No. 1, gate house

Description: The gate house consists of a concrete walled structure with opening to the dam upstream. The gate house has a bar trash rack over the discharge opening and a control gate with hoister and stem rod connection to the gate. It is believed that the concrete gate house is a newer structure, built

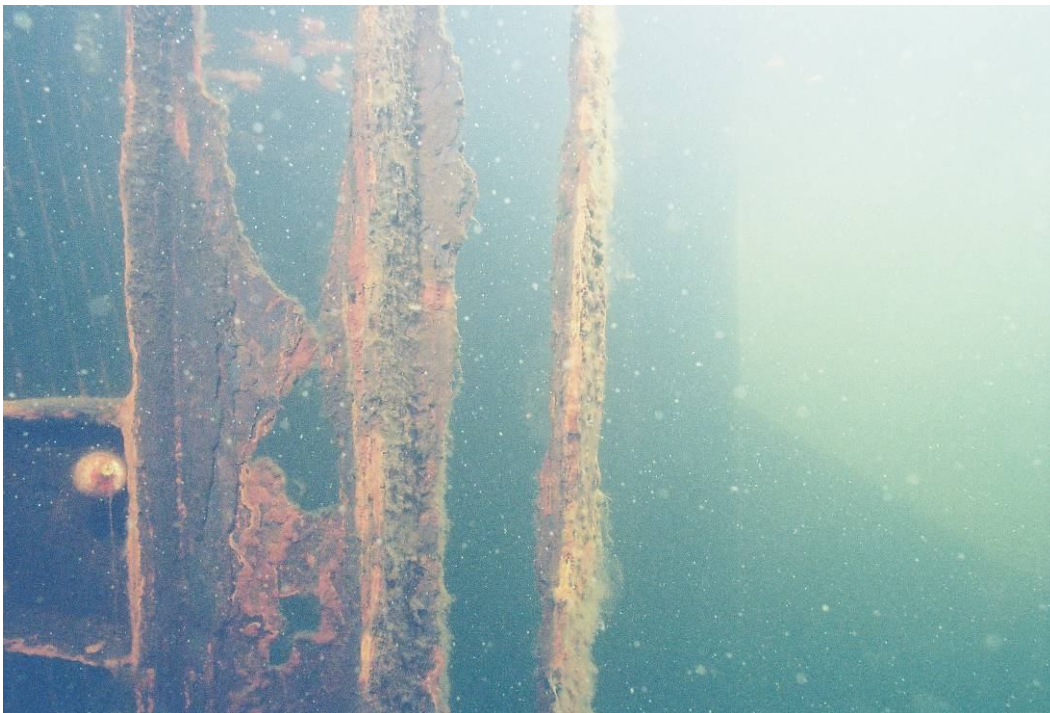
Directly in front of the trash rack and in the center of the opening are two vertical "I" beams connected flange to flange. The I beams provide support for the platform above and center support for dewatering timbers which can be placed in stop log channels cast in either side of the concrete opening (See photograph #7 following). The I beams are braced horizontally by steel support members which are connected to horizontal trash rack supports behind (Note figure 1 following). The vertical I beam and horizontal supports are heavily rusted and deteriorated (75 -90%) and their web sections are perforated and very weak (See photograph No. 3, 4, following). The trash rack is supported by two horizontal I beams which span the gate house opening. The beams are spaced approximately 4 feet apart off the floor and above. The lower beam section measures approximately 12X16 inches and is approximately ½ inch in thickness. The beam appears heavily rusted and has sectional loss from deterioration of approximately 15-25%. The upper beam measures approximately 8 X 12 inches and is approximately 3/8 to ½ inch in thickness. The beam appears heavily rusted, the edges of the flanges are somewhat "knife edged" and the beam has sectional loss from deterioration of approximately 25-50%. The beams are connected to the gate house walls via flange brackets which are anchored into the walls using approximately ½ inch fasteners. The fasteners were heavily rusted.

PHOTO #3, SHOWING VERTICAL I BEAMS WITH PERFORATED WEB SECTION

1. Support vertical I beams and horizontal braces under the platform are very deteriorated with perforation of web sections.
2. The trash rack has deterioration to underwater sections but may be serviceable.

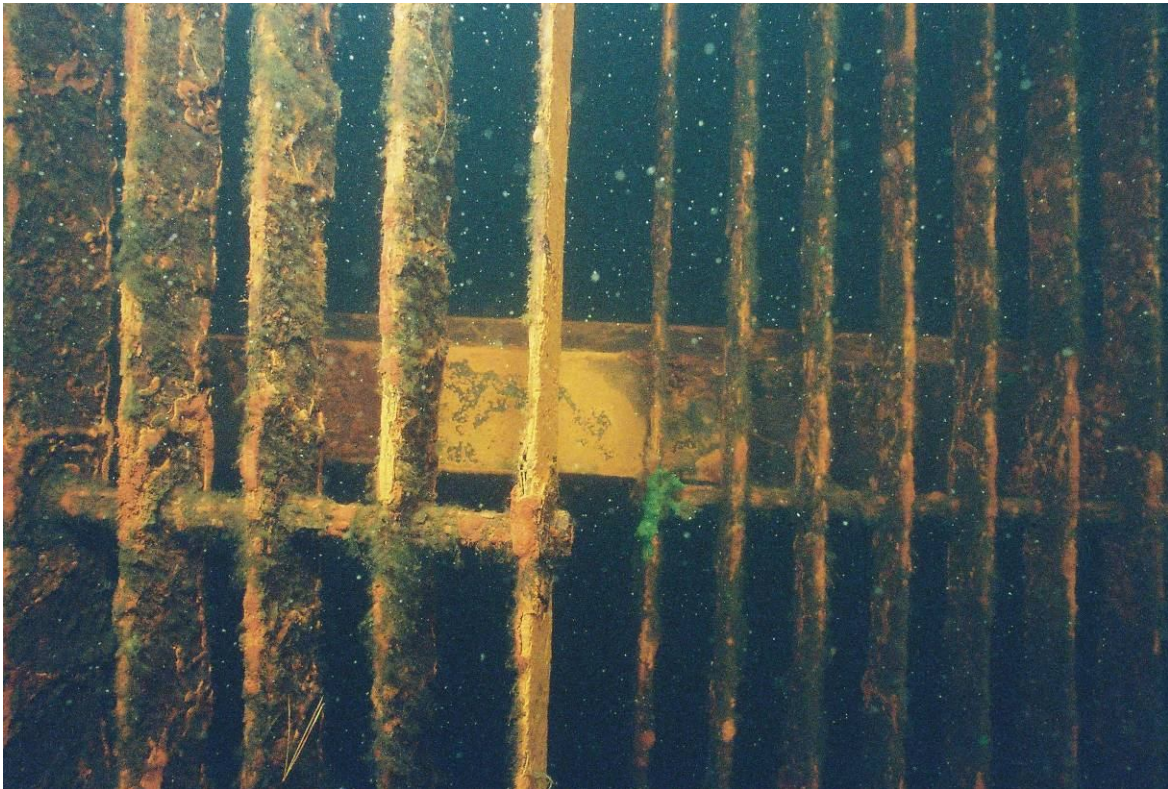
1. Trash racks and supports: The trash rack consists of multiple, approx. 4 foot sections spanning the gate house opening. The trash rack is constructed of approx. 4 inch X ¼ inch steel bars spaced approximately 4 inches apart. Sections of the trash rack above the water appear original in thickness and are in good condition, sections of the trash rack below water, particularly just below the average water line show heavy rust and deterioration reducing the bar thickness by 25 to 50% (See photograph No. 2, following). Fasteners holding the bars together appeared heavily rusted. A section of rack was pulled forward to gain access to the gate. The section appeared reasonably sound and did not fall apart during the move.

PHOTO #2 SHOWING TRASHRACK DETERIORATION, NOTE HORIZONTAL SUPPORT BEHIND

3. The horizontal support I beams behind the trash rack have some deterioration but may be serviceable.
4. The bracket connection from the support I beams to the wall has deterioration to the fasteners.

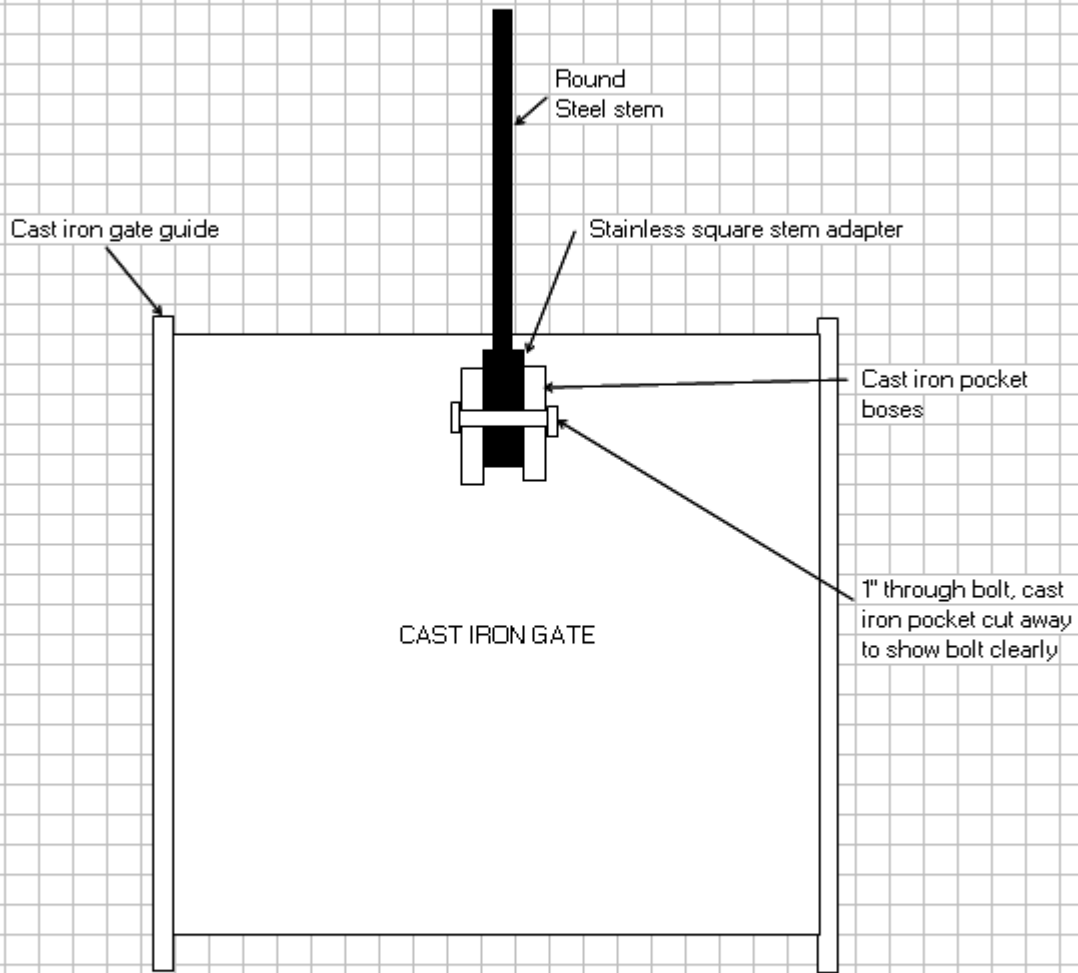
PASCOAG RESERVOIR UPPER DAM
FIGURE 2
ELEVATION VIEW OF GATE SHOWING STEM POCKET

8. The existing stem appears to be twisting in the pocket which connects the stem to the gate.

Notes: The sketch above shows the gate and details of the connection of the stem to the gate.
