**FIELD SUMMARY REPORT  
INSPECTION OF THE PASCOAG UPPER RESERVOIR DAM  
LOW LEVEL OUTLET**

**Pascoag, RHODE ISLAND**

**OCTOBER 2010**

**REPORT PREPARED BY  
INNER TECH MARINE SERVICES LLC**

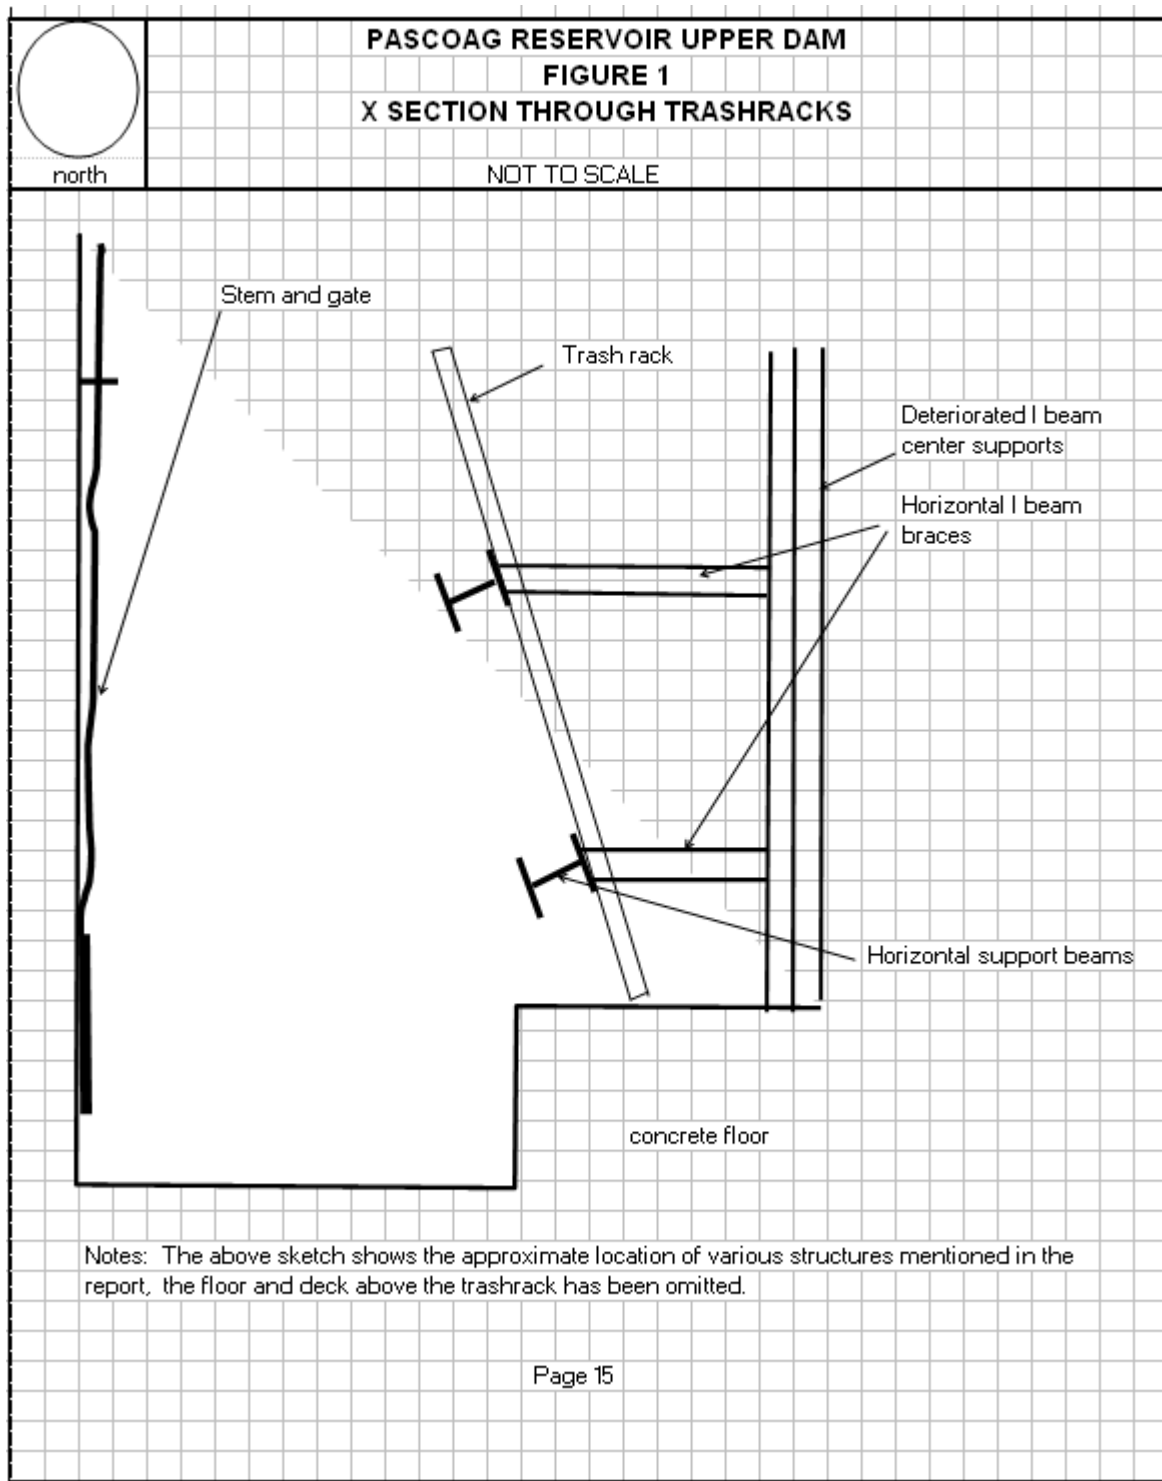
**1. Trash racks and supports:** The trash rack consists of multiple, approx. 4 foot sections spanning the gate house opening. The trash rack is constructed of approx. 4 inch X ¼ inch steel bars spaced approximately 4 inches apart. Sections of the trash rack above the water appear original in thickness and are in good condition, sections of the trash rack below water, particularly just below the average water line show heavy rust and deterioration reducing the bar thickness by 25 to 50% (See photograph No. 2, following). Fasteners holding the bars together appeared heavily rusted. A section of rack was pulled forward to gain access to the gate. The section appeared reasonably sound and did not fall apart during the move.

Directly in front of the trash rack and in the center of the opening are two vertical "I" beams connected flange to flange. The I beams provide support for the platform above and center support for dewatering timbers which can be placed in stop log channels cast in either side of the concrete opening (See photograph #7 following). The I beams are braced horizontally by steel support members which are connected to horizontal trash rack supports behind (Note figure 1 following). The vertical I beam and horizontal supports are heavily rusted and deteriorated (75 -90%) and their web sections are perforated and very weak (See photograph No. 3, 4, following). The trash rack is supported by two horizontal I beams which span the gate house opening. The beams are spaced approximately 4 feet apart off the floor and above. The lower beam section measures approximately 12X16 inches and is approximately ½ inch in thickness. The beam appears heavily rusted and has sectional loss from deterioration of approximately 15-25%. The upper beam measures approximately 8 X 12 inches and is approximately 3/8 to ½ inch in thickness. The beam appears heavily rusted, the edges of the flanges are somewhat "knife edged" and the beam has sectional loss from deterioration of approximately 25-50%. The beams are connected to the gate house walls via flange brackets which are anchored into the walls using approximately ½ inch fasteners. The fasteners were heavily rusted.

1. Support vertical I beams and horizontal braces under the platform are very deteriorated with perforation of web sections.
2. The trash rack has deterioration to underwater sections but may be serviceable.

3. The horizontal support I beams behind the trash rack have some deterioration but may be serviceable.
4. The bracket connection from the support I beams to the wall has deterioration to the fasteners.

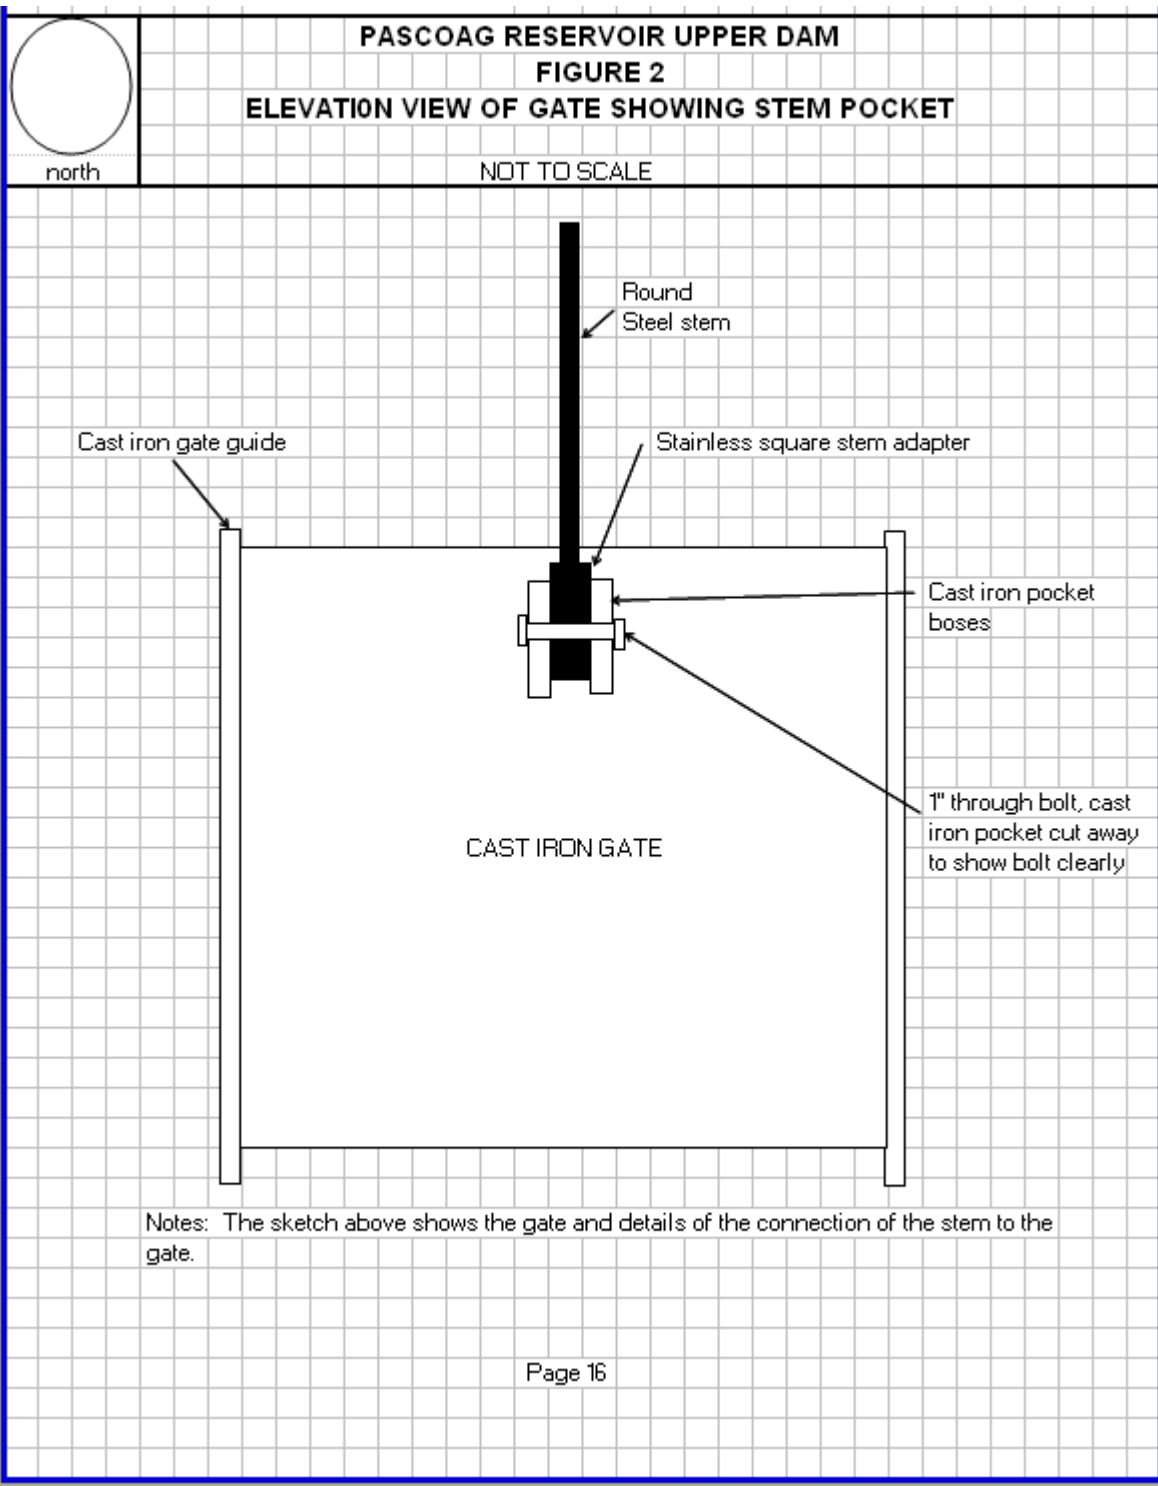
this softness was due to chipping on outer layers of deterioration or deeper deficiencies in the cast iron. There are no upper gate guides above the gate frame to guide the gate back over the opening. The gate appeared opened approximately 1-2 inches, enough to cause a leak across the bottom but apparently not opened above the square gate frame behind. Some leakage was noted along the sides of the gate. Sticks and debris were mostly clogging the openings and controlling leakage.

The gate is opened and closed via a steel shaft measuring approximately 2 ½ inch in diameter. The steel shaft or “stem” is heavily rusted. The stem is severely bent in an “S” shape, most likely from over closing or excessive down force needed to close the gate. The lower section of stem terminates in an approximately 4 inch square stainless steel member spliced (welded) onto the round stem section. The stainless member sits in a rectangular pocket cast into the gate. The stainless member is through bolted (approximately 1” bolt) through the cast in pocket in the gate. Smaller fasteners were also noted in the face of the stainless member. These fasteners are believed to be threaded through the stainless into threads cut into the face of the gate pocket. The fasteners were rusted and loose, some evidence of the square stainless member twisting in the square cast gate pocket was evident. Figure 2 and photographs No’s 5 and 6, following, show additional details of gate construction and condition. No upper stem guides, to control flex in the stem, were observed. The stem is flange coupled above and out of the water to an acme threaded stem (approximately 3 inches in diameter) section passing through a hole in the gate chamber floor.

6. The gate frame does not have upper guides causing the gate to skew in the guides below during closing.
7. The gate cast iron appeared to be somewhat soft when probed with a pick; the gate is leaking which suggests deterioration to sealing surfaces.

8. The existing stem appears to be twisting in the pocket which connects the stem to the gate.
