FLOOD INUNDATION MAP

FLOOD PLAIN MANAGEMENT STUDY
 PASCOAG RESERVOIR UPPER AND LOWER DAMS

Burrillville, Rhode Island November 1988

SOIL CONSERVATION SERVICE
 U.S. DEPARTMENT OF AGRICULTURE

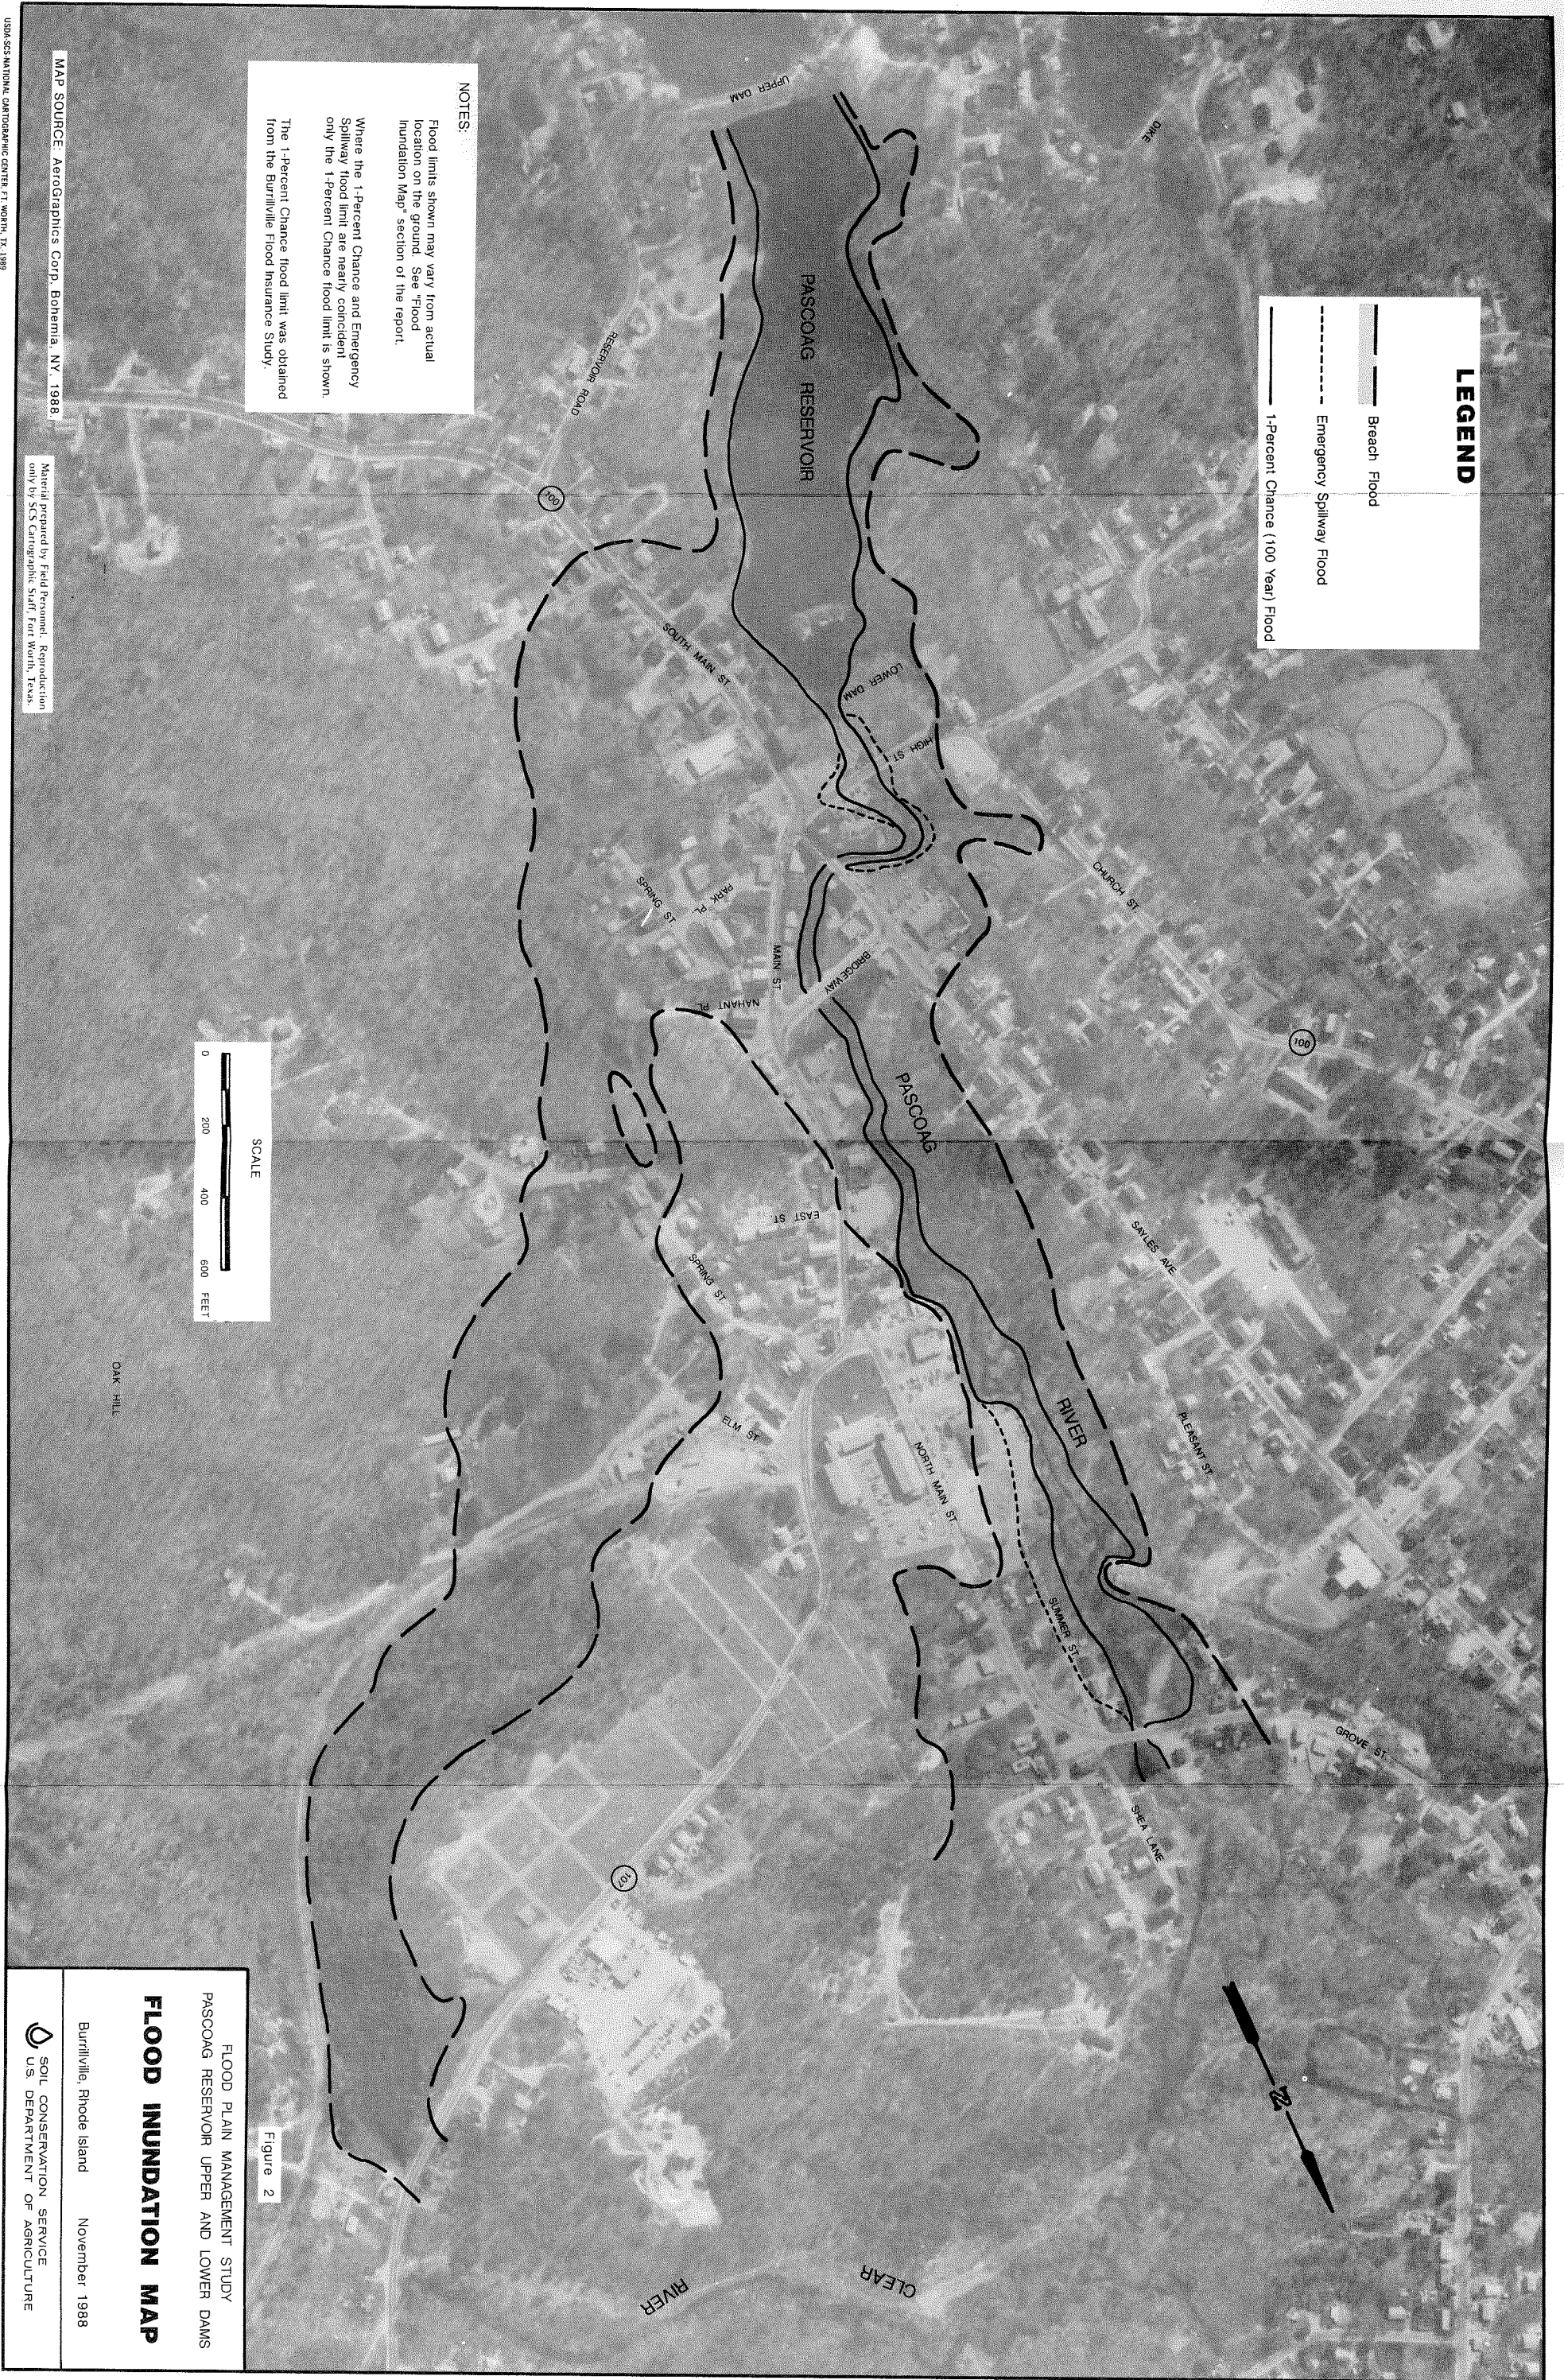
Figure 2

Flood limits shown may vary from actual location on the ground. See "Flood Inundation Map" section of the report.

Where the 1-Percent Chance and Emergency Spillway flood limits are nearly coincident only the 1-Percent Chance flood limit is shown.

The 1-Percent Chance flood limit was obtained from the Burrillville Flood Insurance Study.
